## HISTORIC PRESERVATION PERMIT

An Historic Preservation Permit for work described below has been issued under the Zoning Ordinance of the City of Tulsa (Section 70.070-K) to **Patricia K Grami**, for the address of **1852 East 16 Street South**, Tulsa, Oklahoma, located in the **Yorktown Historic Preservation Overlay District**. This proposal has been approved by the Tulsa Preservation Commission Staff. Staff Approvals are issued with the following conditions:

1. Repair and replacement of in-kind window trim
2. Repair and replacement in-kind of columns on porch

Date issued: 01/12/2024  
Expiration: 01/13/2026  
Number: HP-0542-2024

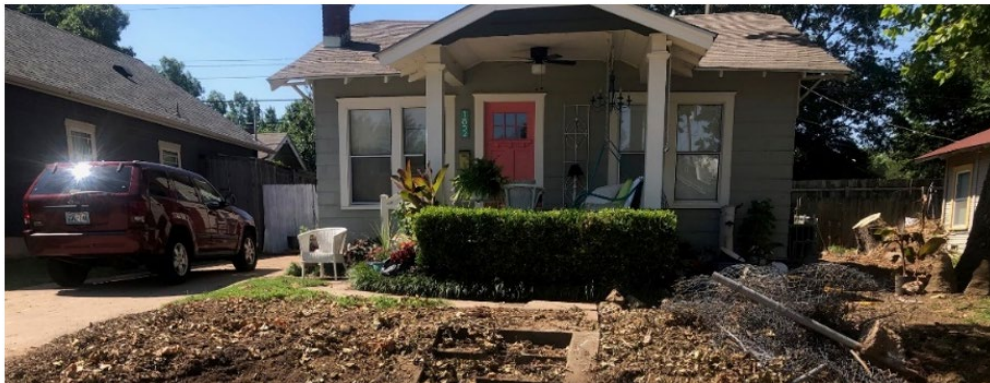
Picture 5, June 27, 2023- the aftermath

~~forgive my skills at trying to get the lines and front of the rafter tails to be angled and proportional.~~ Note the east side porch post was broken in the storm and is being rebuilt and will exactly match the original

All wood trim and wood window framing including all trim above, and the mullion trim between the 3 sets of full-sized double windows will be retained and repaired if possible, or be replaced with exactly the same type, shape, of wood and painted to match. They are building or rebuilding the exact same wood sill, sill plate, jamb, exterior header, sheathing, drip cap, casing, etc. as would have been there originally in 1915.
