# TULSA PRESERVATION COMMISSION

## STAFF REPORT

HP-18-024

**PROPERTY ADDRESS:** 1565 SOUTH YORKTOWN AVENUE

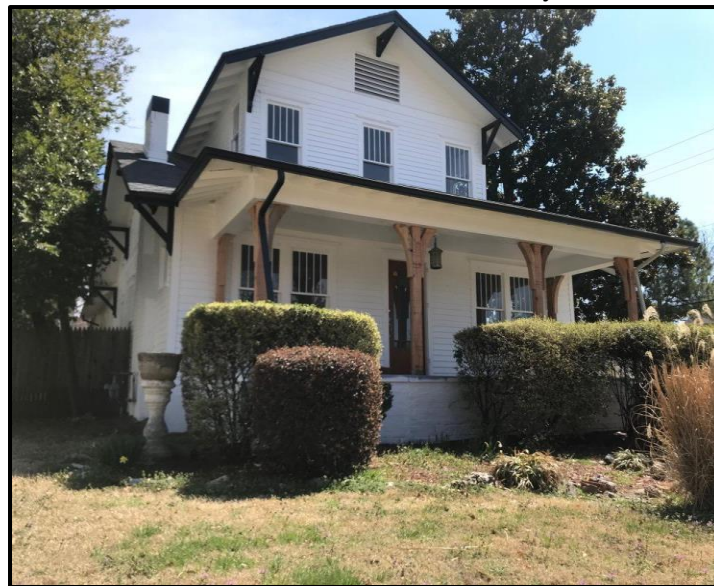
1565 South Yorktown Avenue – March 2018

- i. The applicant proceeded with the replacement of the wrought-iron columns previously on the porch after assessment of their condition. The newly installed columns are cedar posts to which brackets have been attached.
